REALIGNMENT OF GANTRY 1

K. Dreyer

The Gantry 1 for proton therapy has been surveyed by the PSI alignment group during construction works in the adjacent PROSCAN area. The installed inclination sensors showed significant irreversible deformation of the foundations and a change in position of the Gantry 1. The new position was measured and realignment was done according to the last known reference coordinates.

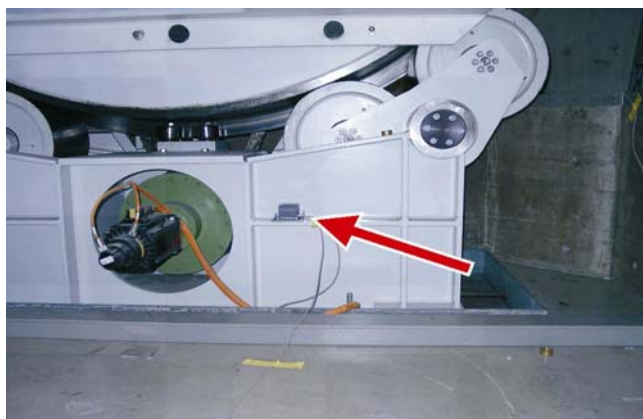
Fig. 1: The picture shows the support frame of Gantry 1. The arrow indicates the location of the inclination sensor N2.

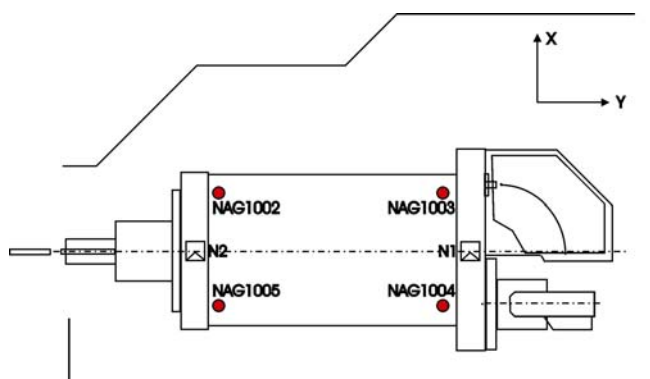
Fig. 2: The layout shows the location of the reference points on top of the Gantry 1 and the two inclination sensors attached to the support system.

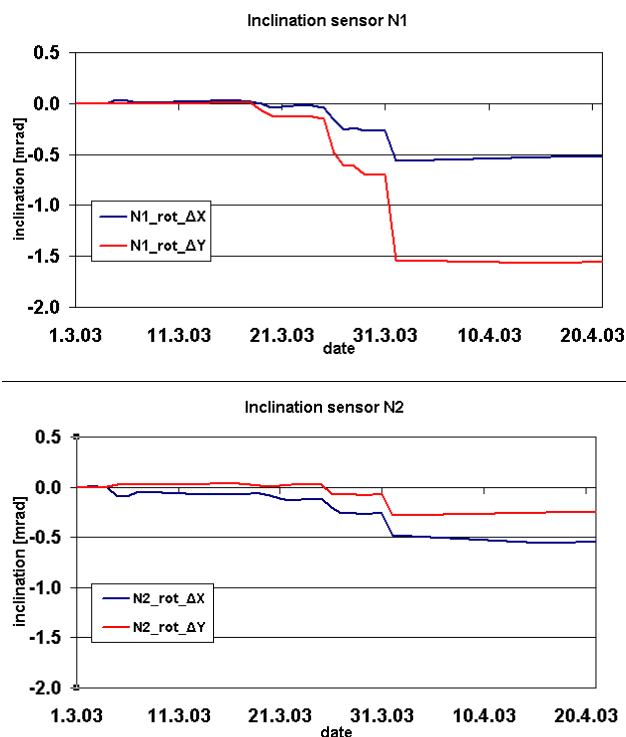
During the preparation of the nearby foundation, serious changes in tilt and level of the Gantry 1 were detected, in parallel to an irreversible deformation of the floor and a misalignment of the Gantry 1. Fig. 3 shows the recorded deviations. The graph of sensor N1 indicates the inclination close to the area where the foundation work took place. Ni_rot_ΔY represents the tilt angle around the beam axis. Curve Ni_rot_ΔX shows the tilt angle perpendicular to the beam axis.

Fig. 3: Inclination values of sensors 1 and 2, during the period from March 1st 2003 to April 20th 2003.

Based on the measured deviations, it was decided to perform a realignment of the Gantry 1. The main goal was a precise positioning (ΔH and $\Delta X < 0.5$ mm) of the Gantry 1 according to the values measured in November 1998. The position in the beam direction (Y) is not adjustable but this is not critical for the reliable operation of the Gantry 1.

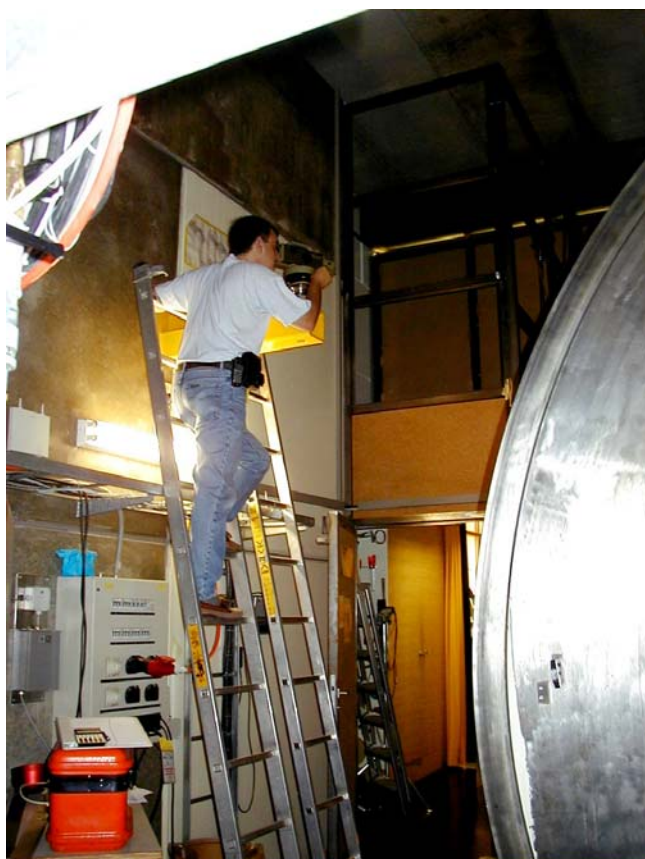
Fig. 4: Measurement of the height of the object reference marks on top of the Gantry 1, using our WILD N3 precision level instrument.
